Conventional Fossil Fired Boilers Ash Hopper Joint

The Ferrybridge power plant had installed an original dipper plate into a water trough to seal the bottom of the boiler to the ash hopper.

Two technical solutions proposed by DEKOMTE

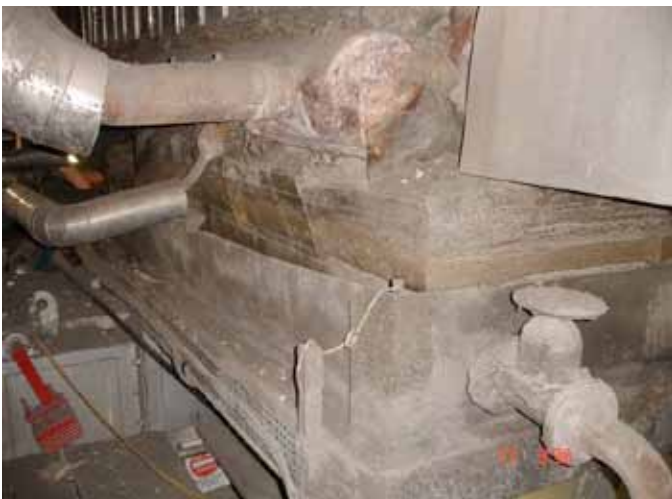
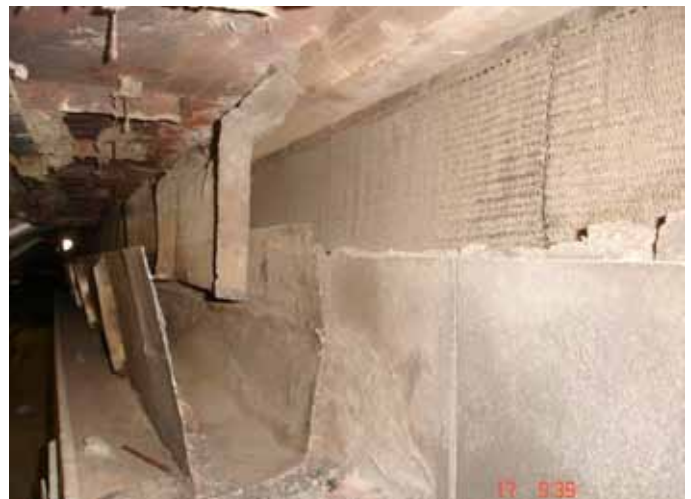
Ferrybridge – Original Design

- contact and deformation of the dipper plate
- distortion of the water trough
- water leakage into the boiler house
- pressure loss due to no sealing of water trough
- regular cleaning and maintenance due to ash build up
- efficiency of draught fans

Ferrybridge original design: Sealing system with dipper plate and water through

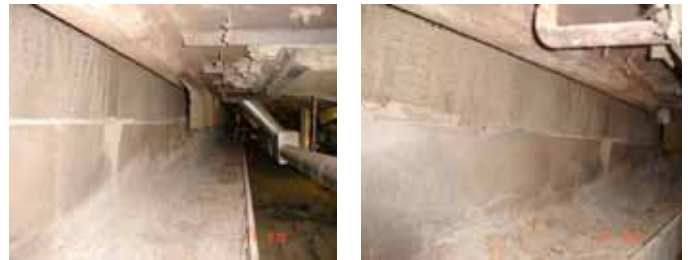
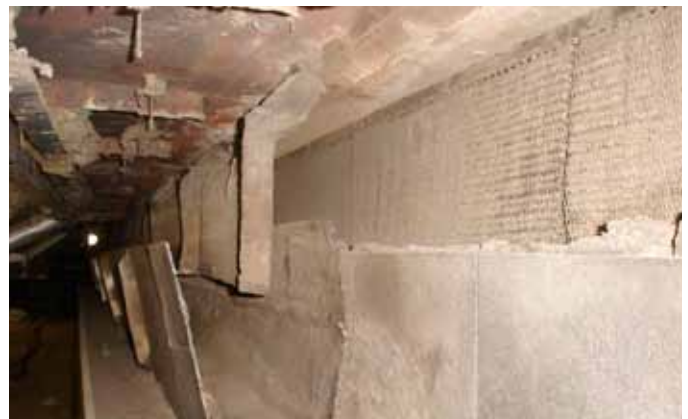
Removal of steel parts

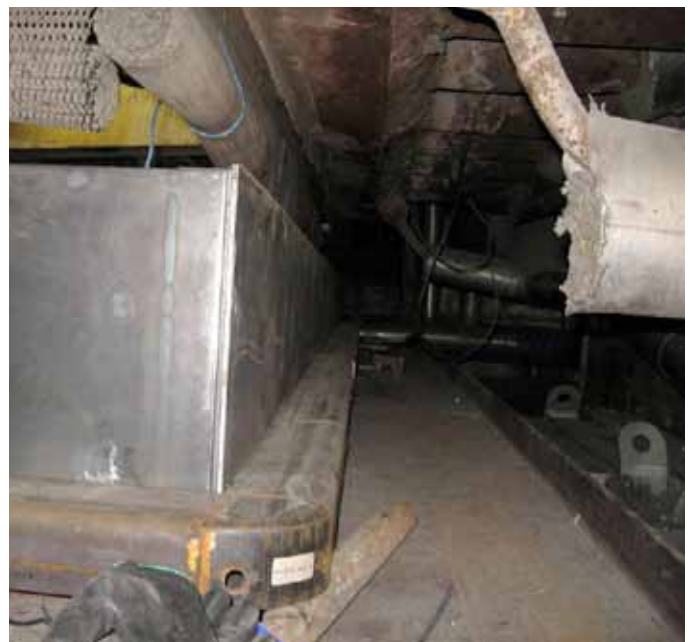
Repair of boiler wall and refractory

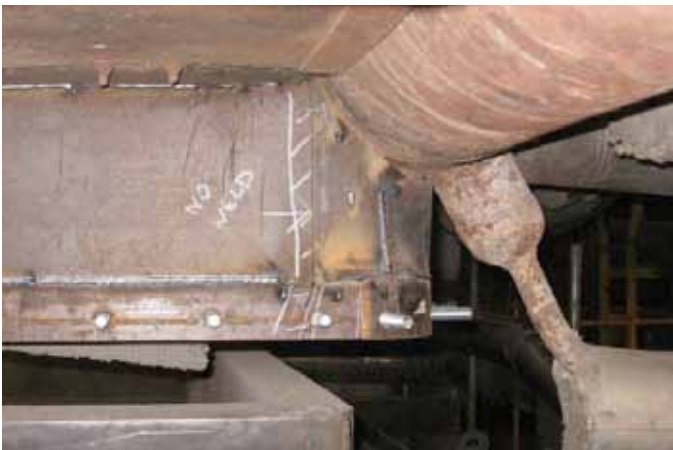
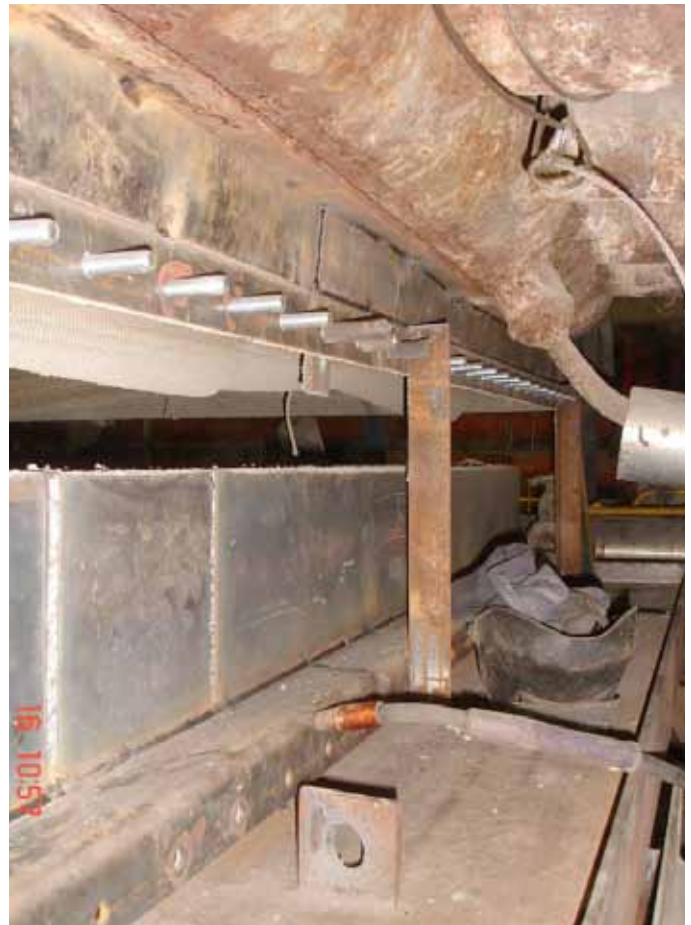
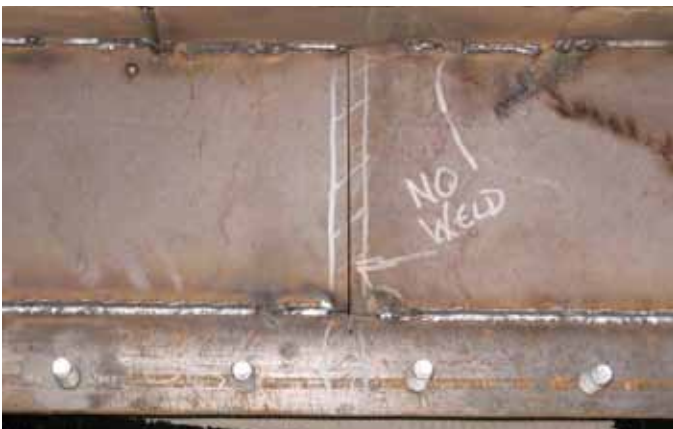
Installation of DEKOMTE steel parts

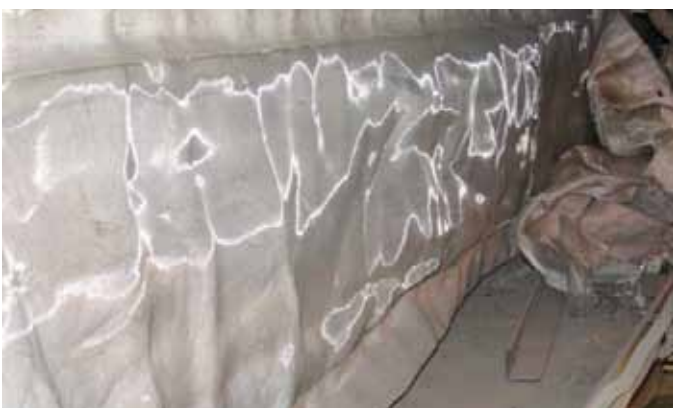
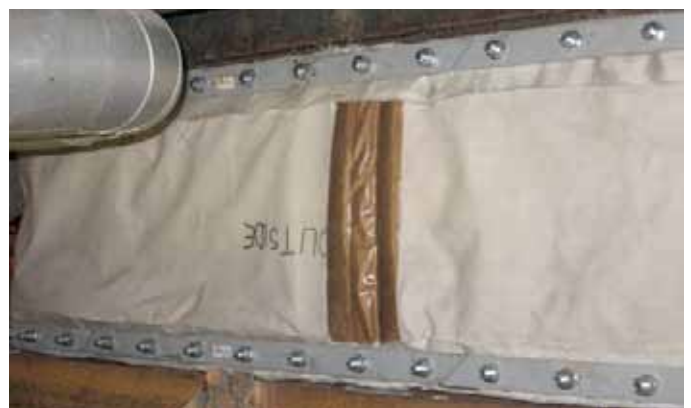
Installation of DEKOMTE internal insulation bolster

Installation of DEKOMTE fabric joint

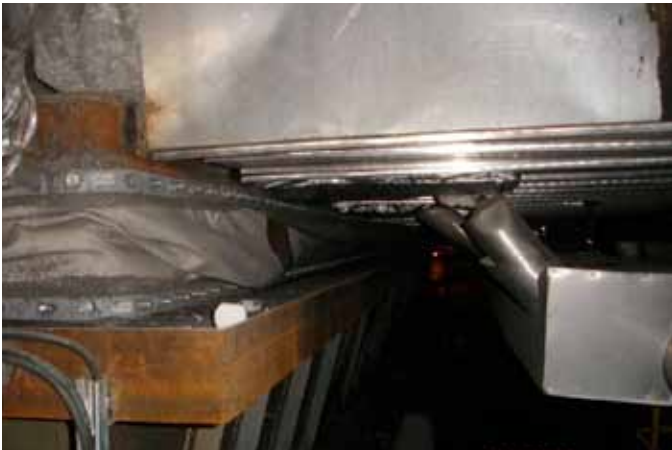
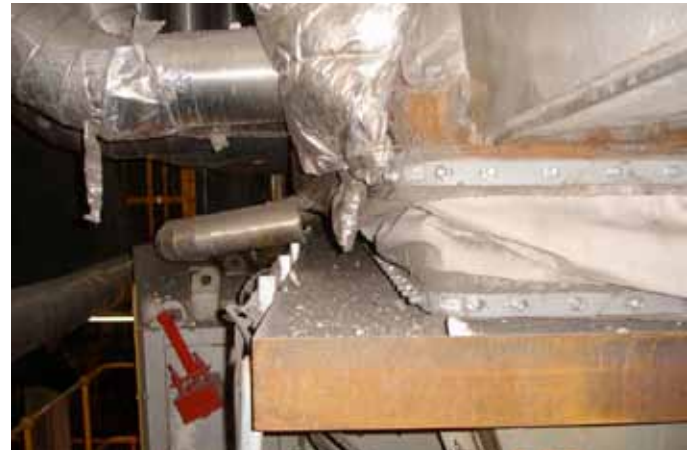
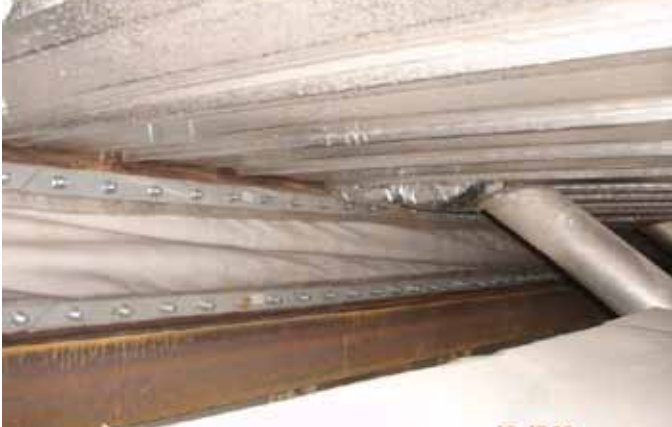
Joint in operation
