Continuous Annealing

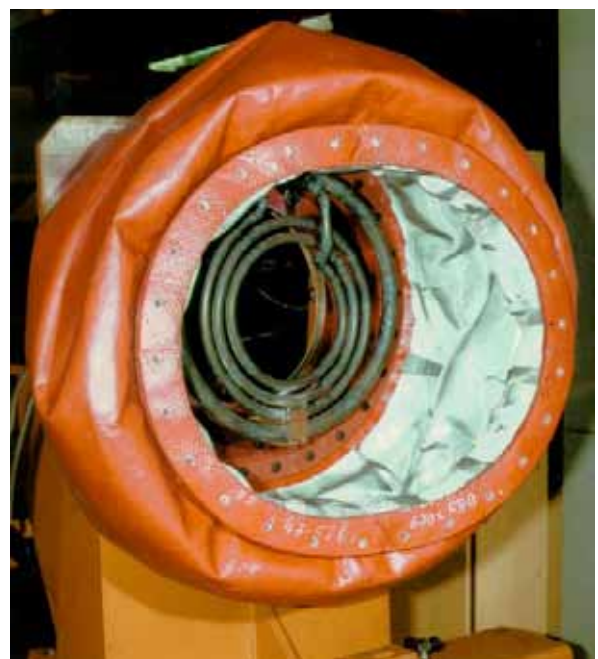
Rotary transmission leadthroughs through container walls cause specific technical difficulties not only under high pressures and high temperatures but also under low pressures and relatively high temperatures. If shafts or arbors are led through container walls, this is connected with the required sealing between the break-through and the container wall.

The example of the continuous annealing plant shows how the sealing of the shaft leadthrough through the furnace wall is controlled with gas-cooled fabric soft material expansion joints. By what compared to steel expansion joints costs for maintenance can be minimised.
