## Metal to Fabric Retrofit

Example for replacement of metal by fabric Mexico

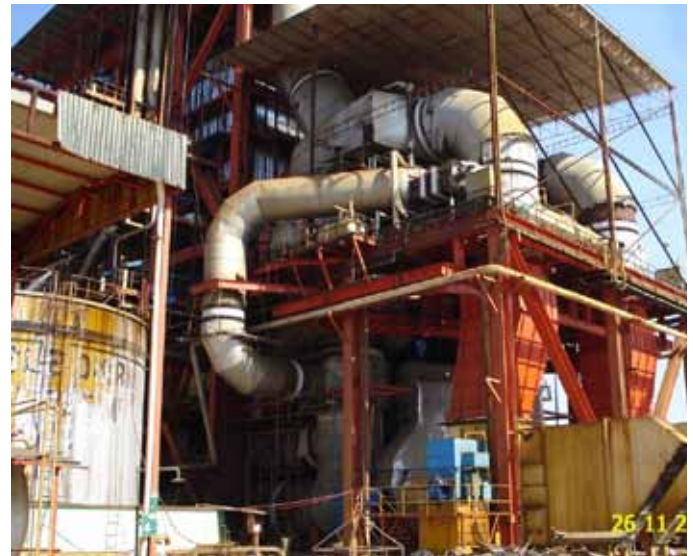
DEKOMTE have carried out a complete replacement of all expansion joints on a 500MW conventional oil fired boiler. The original metallic bellows required welding, patching and repairing on an annual basis.

Fan capacity and boiler efficiency was detrimentally affected by expansion joint leaks and failures.

The new DEKOMTE fabric solution, gave a turnkey scope of supply, solving steel, fabric and adjacent insulation issues. A long term warranty and extended maintenance cycle gives assurance to the power station of running and plant efficiency
